Damp houses can be unhealthy and costly to remedy. Knowing more about the problems can reduce the worry and expense. Most dampness problems can be cured or minimized by simple remedial work but a few will need substantial outlays. This sheet outlines the causes and remedies of dampness.

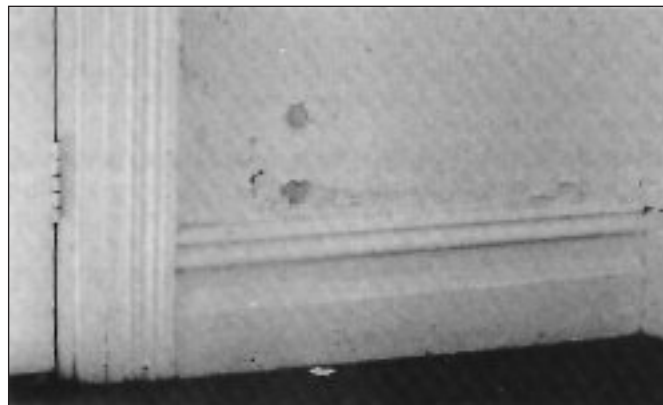
Figure 1. Rising damp lifting finishes.
